Summer 2007 Flood Report

LCRA Water Services

River Operations Center

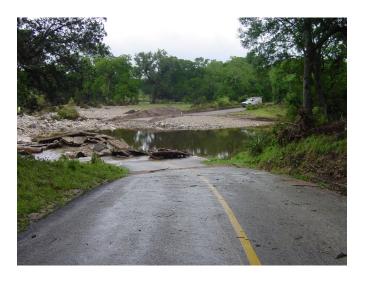
Washout of FM 2147 at Double Horn Creek southeast of Marble Falls

To the east along the south side of Lake Travis, Double Horn Creek experienced similar conditions and washed out a county road crossing on the south side of Lake Travis.

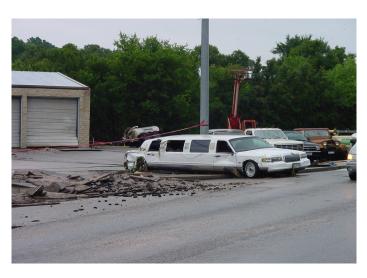
Damage from flash flooding on Whitman Branch in Marble Falls
